PIKE TOWNSHIP
MUNICIPAL AUTHORITY
DAM

NDS I. D. No. PA-00916
PENNDER I. D. No. 17-111

PHASE I INSPECTION REPORT
NATIONAL DAM INSPECTION PROGRAM

PREPARED BY
GAI CONSULTANTS, INC.
570 BEATTY ROAD
MONROEVILLE, PENNSYLVANIA 15146
APRIL 1979

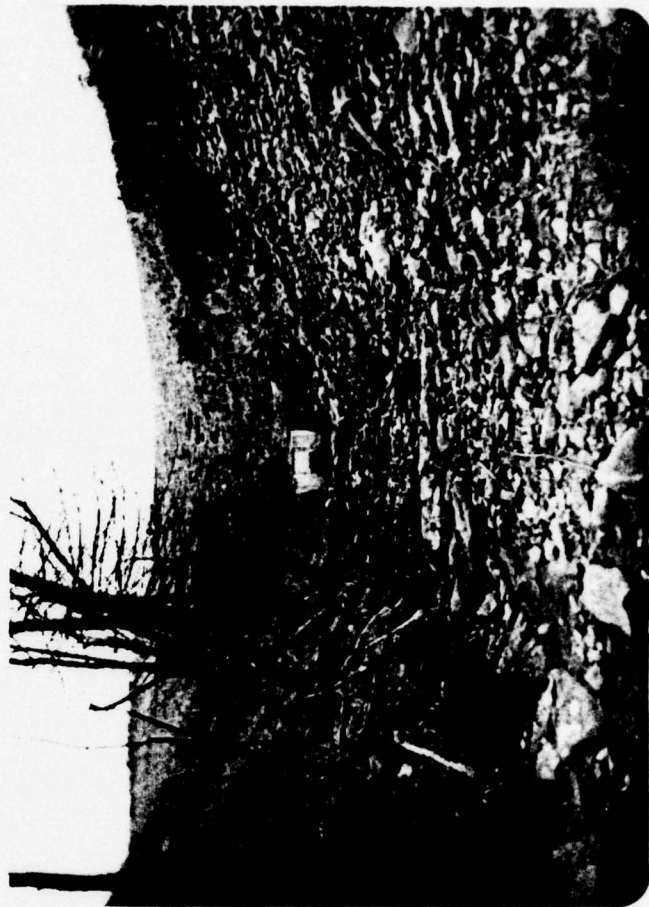
PHOTOGRAPH 4 View of the outlet structure.
